SERVICE MANUAL

200-300 Series

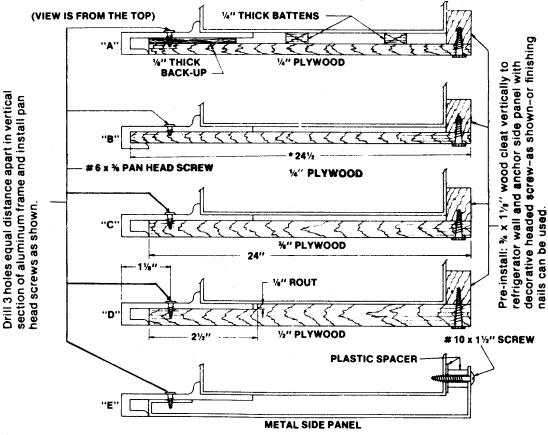
Dimensions given for typical side panel installation. Note: if 1/4" panel is used and inserted into return channel extrusion then a 24-1/2" size is necessary for width. Sheet must also be notched for grille. This is only necessary on this application.

*If %" panel is used and inserted into return channel extrusion, then a 24%" size is necessary for width.

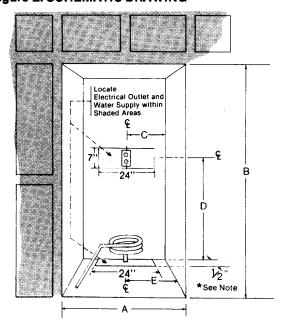
Figure E. SCHEMATIC DRAWING

NOTE: Water line may come directly through the wall, not higher than 2-1/2" from floor level.

- 3) With panel in position, replace frame molding and handle. Replace and tighten all screws. Special care should be taken not to overtighten and "strip" screws. Please refer to Figure E SCHEMATIC DRAWING for front panel dimensions. If side panels are being utilized, please refer to detailed side panel installation instructions.

- 1. Remove door handle. Handle is located on the top on 22IM and 245 models, and on the side on other models. Handle is held on with Phillips head screws.
- 2. Slide $1/4^n$ thick panel into frame on door. Door must be open 90^o on 245 models. If a thinner panel is used, install chipboard filler panels behind the trim panel for proper fit. IMPORTANT: Routing may be required on some panels for finger clearance under handle.
- 3. With panel in position, replace handle. Replace and tighten all screws. Do not overtighten and 'strip' screws. Refer to Figure E schematic drawing for front panel dimensions.

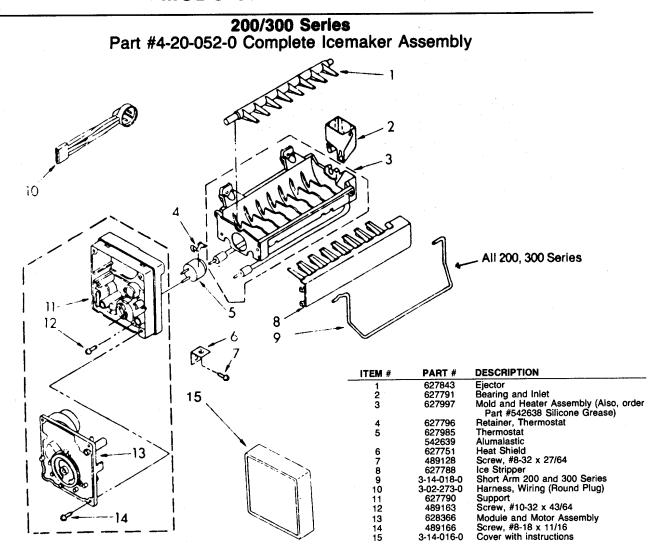
MODULAR BREAKDOWN

- a. Test points L & N will verify 120 volts to icemaker module. (Make sure your test probes go into the test points 1/2").
- b. Test points T & H will verify if the bimetal thermostat is open or closed.
- c. Short T & H with an insulated peice of wire (14 gauge) to run the motor. If the motor doesn't run, replace the module assembly; if the motor runs, replace the bimetal thermostat.
- d. If you leave the jumper in for half of a revolution, you can feel the heater in the mold heat up. . . if it's good.
- e. Remove the jumper and the water valve will be energized in the last half of the revolution. (Make sure that the freezer temperature is cold enough to close the bimetal).

a. Test points L & H will check the resistance of the heater (72 ohms). Replace the mold and heater assembly if not near this valve (± 10 ohms). (Ejector blades should be at the end of the cycle position or the 1:30 o'clock position).

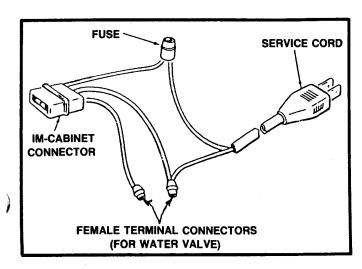
A special icemaker test cord can be made for bench repair using the cabinet icemaker connector. The same cord made for the 'Remote Valve' type icemaker can be used (see figure A).

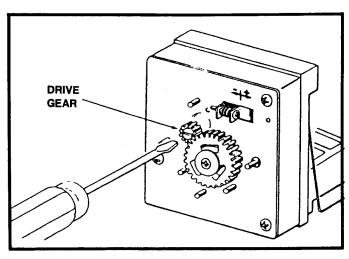
To manually start a cycle, first remove the front cover by prying loose with a coin at the bottom of the support. Please use the blade of a flat screwdriver in the slot located on the drive gear (see figure B). Turn counter-clockwise until the holding switch clicks in and circuit is made to the icemaker motor. The icemaker will then complete its cycle itself.

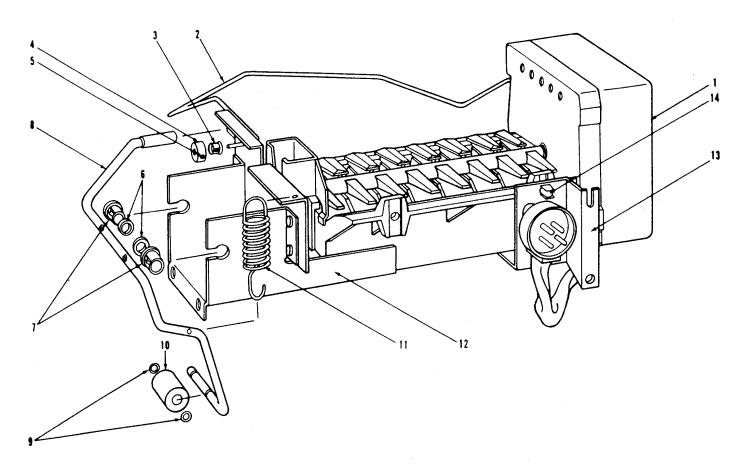
4-20-031-0 COMPLETE ICEMAKER ASSEMBLY

Item #	Part #	Description
1 2 3 4 5 6 7 8 9 10	4-20-031-0 2-8094-01 3-22-020-0 3-45-042-0 6-11-050-0 6-24-018-0 3-22-018-0 3-42-087-0 3-45-033-0 3-42-088-0 3-45-036-0	Icemaker Assembly Shut-Off Arm Snap Bushing 1/4 x 1/8 Shaft Collar Set Screw, #8-32 x 3/16 Nylon Washer .437 x .260 Snap Bushing, 3/8 x 1/4 Icemaker Arm Guide Plastic O-Ring, .145 x .070 Roller, .75 x .25 x 1.0 Extension Spring, .75 x .055 x 2.0
12 13 14	4-16-039-0 0-23234-0 6-22-022-0	IM Sensor Return Mechanism IM Bracket Screw Grommet, 1/32 x 3/8 sq

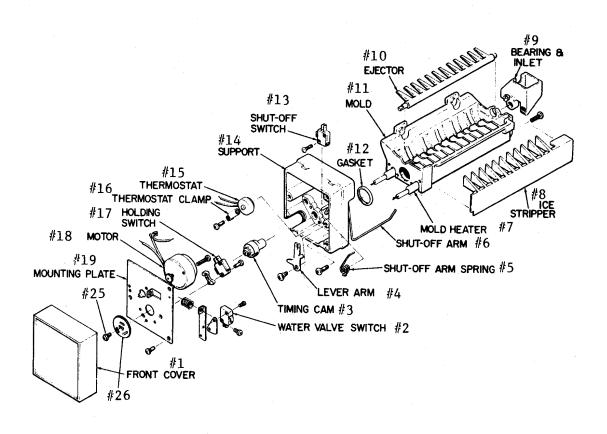
COMPACT ICEMAKER #3-14-001-0 8 CAVITY

Item #	Part #	<u>Description</u>	Item #	Part #	Description
1	833873	Front Cover	14	625827	Support
2	627851	Water Switch	15	627180	Thermostat
3	625913	Timing Cam		627333	Thermostat*
4	625830	Lever Arm			(*Canadian use)
5 6	480855	Shut-off Arm Spring	16	625829	Thermostat
6	627003	Shut-off Arm	17	627848	Holding Switch
7	625893	Mold HeaterKit	18	798654	Motor Kit
8	627753	Ice Stripper	19	62583 3	Mounting Plate
9	833593	Bearing/Inlet Kit	20	625914	Gear
10	627169	Ejector	21	488806	Screw
11	627170	Mold	22	488787	Screw Mtng Plate
12	625828	Gasket	23	833873	Front Cover
13	625851	Shut-off Switch	24	488896	Screw
			25	488806	Screw
			26	628210	Gear

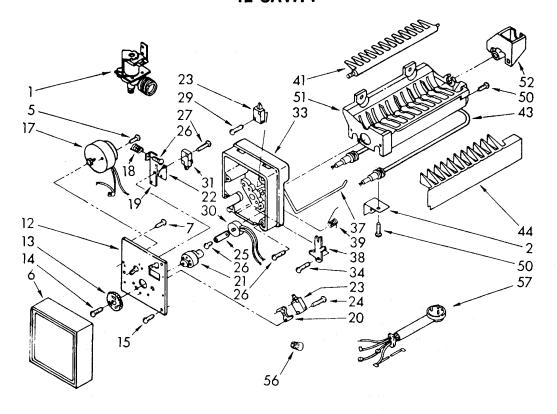
ICEMAKER PARTS #3-14-007-0 12 CAVITY

Item #	Part #	Description	Item #	Part #	Description
1	3-09-002-0	Valve Assy	24	488361	Screw, 4-40 x 1
2 5	625910	Bracket	25	625829	Clamp (alternate)
5	488361	Screw (use	26	488372	Screw, 8-32 x 1
		w/625846 mtr)	27	488362	Screw, 4-40 x 3/4
	488622	Screw (use	29	488360	Screw, 4-24 x 3/4
		w/627106 mtr)	30	627180	Thermostat*
6	833873	Cover	31	627848	Switch, Holding
7	488542	Screw (ground)	33	625827	Support
12	625833	Mounting Plate	34	833587	Screw, shoulder
13	525914	Gear	37	627003	Arm, Shut-off
14	488806	Screw	38	625830	Arm. Lever
15	488787	Screw, #8-18 x 1/2	39	480855	Spring,Shut-off
17	798654	Motor	41	627375	Ejector
	627106	Motor (alternate)	43	625893	Heater, Mold
18	627163	Spring	44	625840	Ice Stripper
19	625836	Plate Valve Switch	50	488896	Screw, 8-16 x 3/8
20	625834	Spacer, Holding Sw	51	833702	Mold/Htr Assy
21	625913	Cam			(incl #43)
22	984683	Insulator	52	833593	Bearing & Inlet
23	627851	Switch, shut off &	56	227991	connector, valve

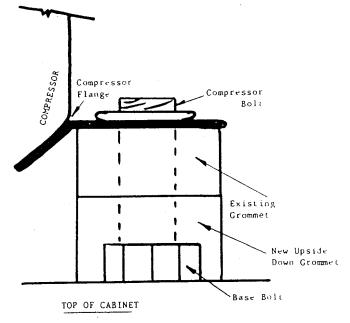
#3-75-179-0 (4-2-85)

- Remove nut off clip from top of (4) compressor bolts.
- Remove washer from compressor bolt.
- 3. Cut top "compressor neck" from the 3-15-017-0 grommet (*see note)
- Lift compressor with existing grommet, off compressor bolt. Also, discard bolt sleeve.
- 5. Position gromment (with neck off) upside down over base bolt.
- Replace existing grommet back onto base bolt with compressor flange inserted into "neck".
- 7. Do NOT replace nut or clip; do NOT replace washer; do NOT replace sleeve.
- 8. Install safety clip over threaded bolt; these can be put on by hand and pushed to the first or second thread (3-45-043-0).
- Check all adjacent tubing to make sure there are no "rattles" or "vibrations".

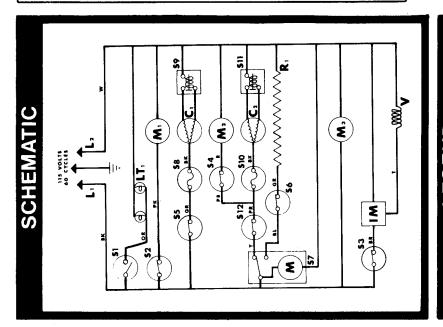
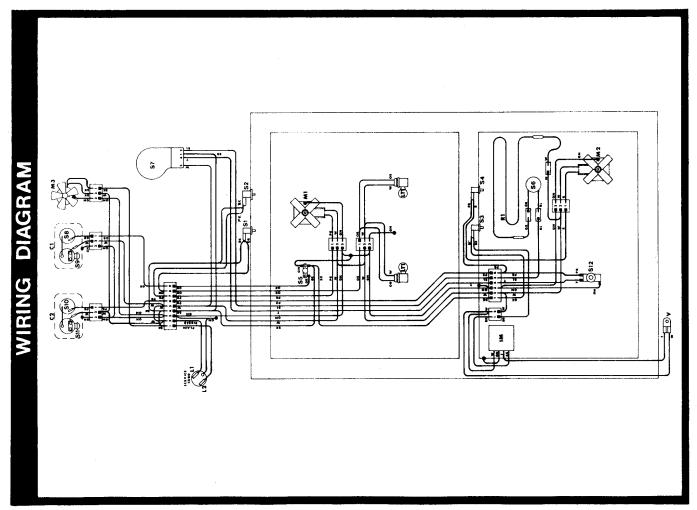
2711 *WIRING DIAGRAM AFTER SERIAL NO. M393733/P397233TO 455970

*NOTE: From M393733 to M455970 No Freezer Light

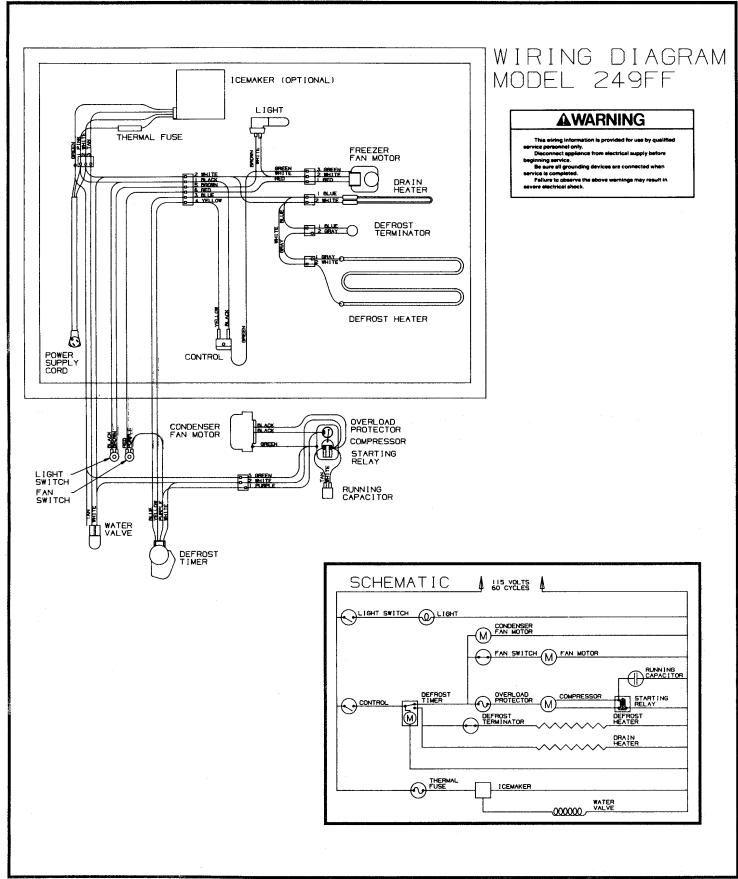
244RFD - 249FF WIRING DIAGRAM AFTER SERIAL NO. 227972 UP TO 662466

PART NUMBER 3752270 REV B

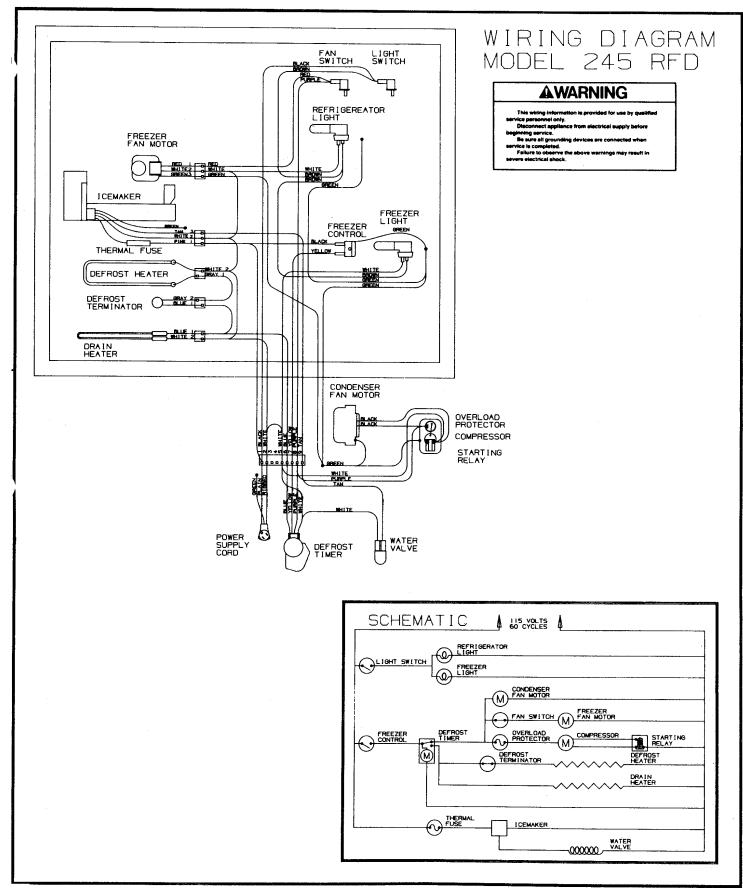
245 WIRING DIAGRAM AFTER SERIAL NO. 464681 UP TO 662066

PART NUMBER 3752260 REV B
